# East Fork Creek Watershed Resource Inventory and Watershed Plan

September 2019

Olson Ecological  
Solutions, LLC

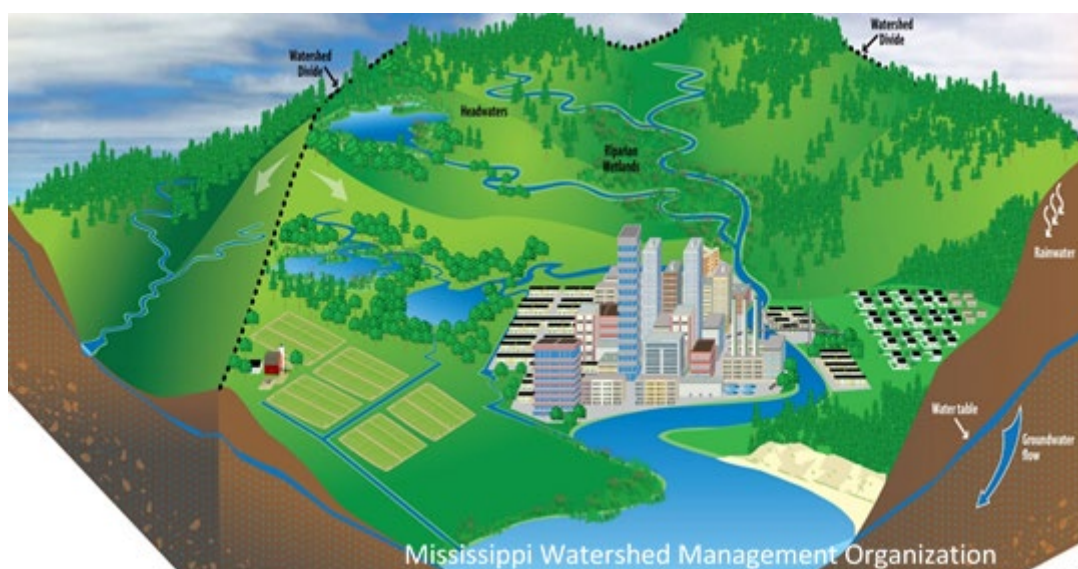
*The black dotted line represents the watershed divide in this illustration. All precipitation that falls within the watershed divide eventually runs to the same stream.*

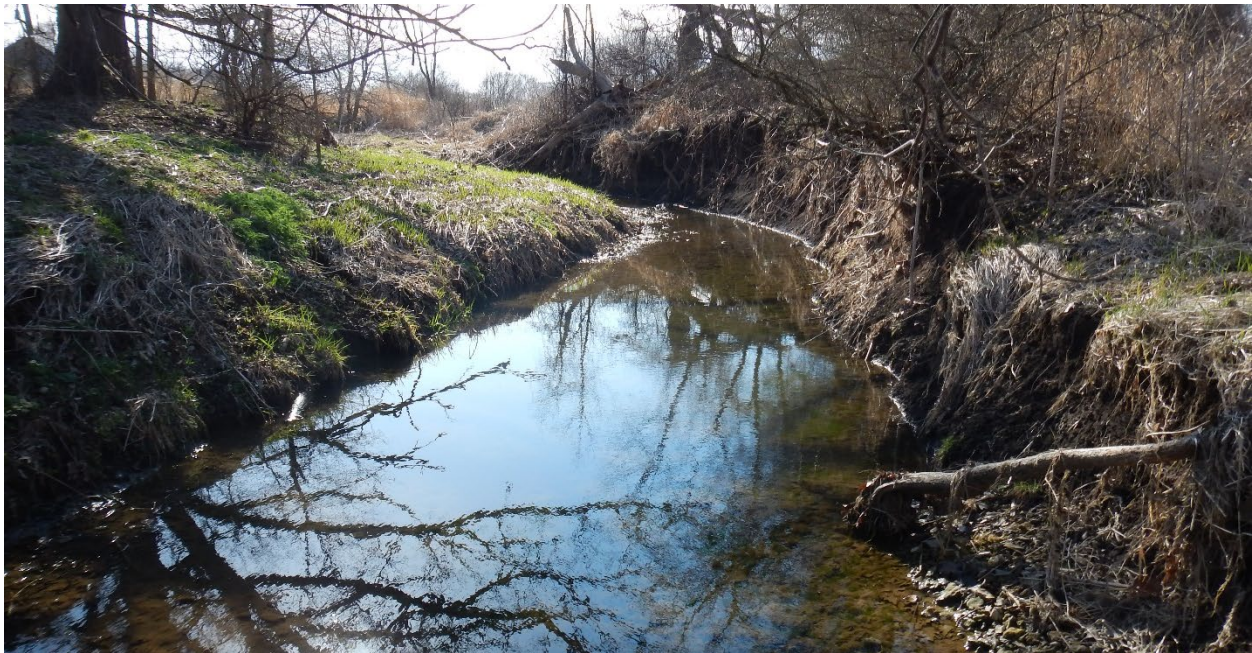
*-Streambanks with varied levels of erosion, photo by Joe Rush*

Erosion concern within the watershed came from soil types and bank erosion and channelization of streams and ravines. The well-drained soils of the watershed tended to have moderate runoff potential and were highly to moderately susceptible to detachment with water. They were not particularly susceptible to wind erosion. Alarmingly, about half (51%) of the banks of streams and ravines were severely eroded. The remaining half of banks were split almost evenly between moderately eroded (23%) and slightly eroded (26%). There was no significant difference between streams and ravines. About one-fifth of streams and ravines were highly channelized (22%), while moderate channelization characterized almost half of the streams and ravines (44%) and little to no channelization was found on another third (34%). These conditions were likely exacerbated by the steep topography of the area, combined with invasion of non-native buckthorn shading out forest floors of their stabilizing vegetation. There was little erosion along the shorelines of small ponds and basins throughout the watershed, and the shorelines of Lake Carroll were completely protected by rip rap in various stages of repair, all with only slight erosion.

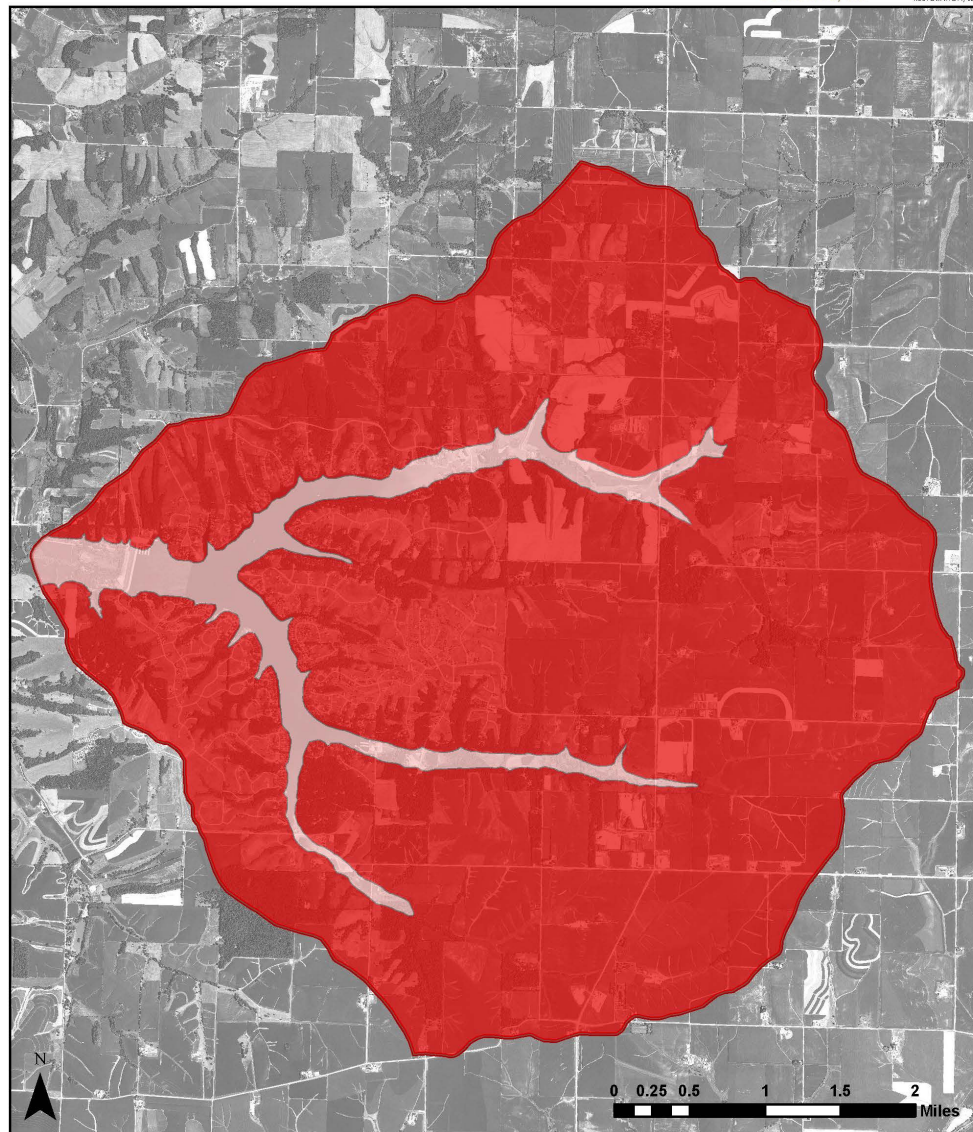
**Bedrock Geology**  
 Maquoketa Shale Group  
 Silurian System  
 East Fork Creek Watershed

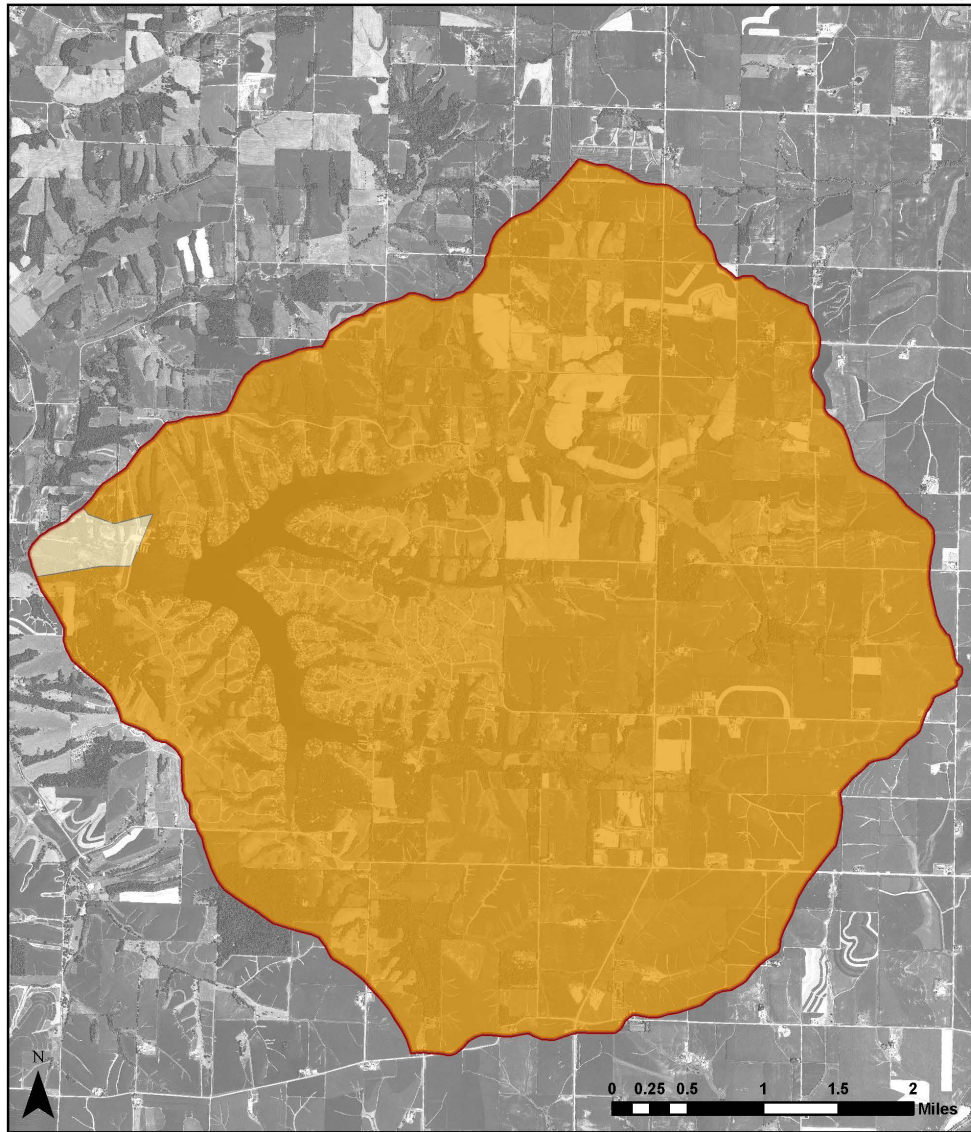
Deposits of Illinois Episode - Illinois Glaciation:  
 Glasford Formation, diamicton deposited as till and ice - marginal sediment  
 Cahokia and/or Henry Formation, waterlain river sediment and wind-blown beach sand  
 East Fork Creek Watershed

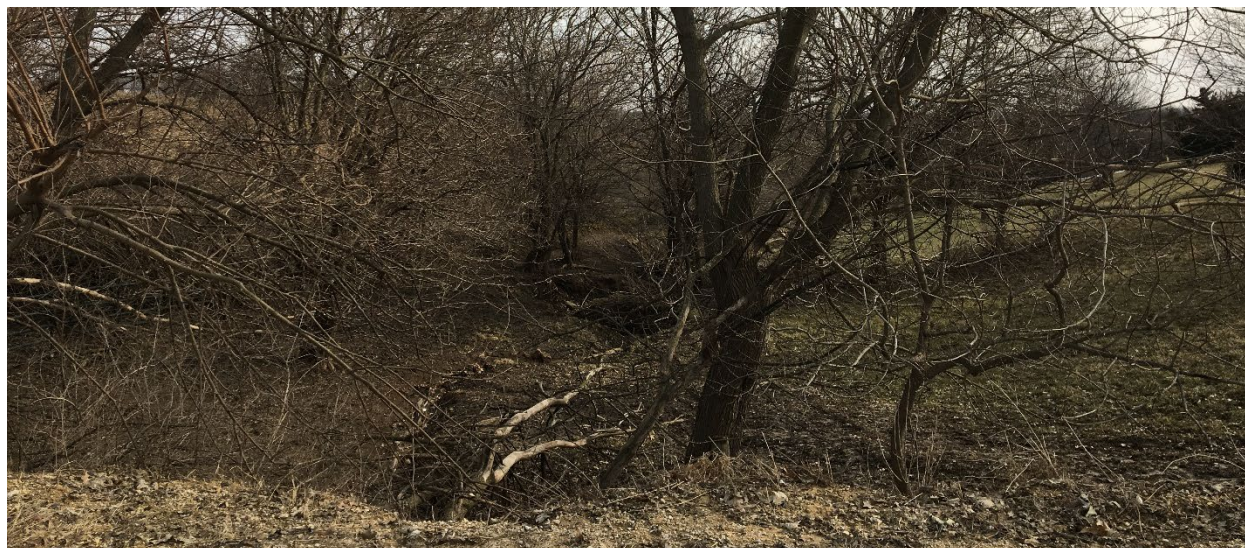
*-Ravine headcut, photo by Rebecca Olson*

Access to install and maintain grade stabilization structures was an issue in some areas near Lake Carroll. Within these areas, forest stand improvement could act alone to allow ravine gullies to self-heal. Ravines with site-specific recommendations could benefit from forest stand improvement on a total of 184 acres of riparian area along 48,446 feet of bank, 24,707 feet of which was highly eroded, as mapped in Chapter 5. Ravines throughout the rural portions of the watershed outside of the Lake Carroll Association are likely accessible. We hope to stabilize the 24,707 feet of site-specific projects plus 25% of the remaining severely eroded banks: 7,845 feet within the Association and 14,576 feet outside of the Association for a total of 22,421 feet of severely eroded ravine banks addressed with watershed-wide projects.

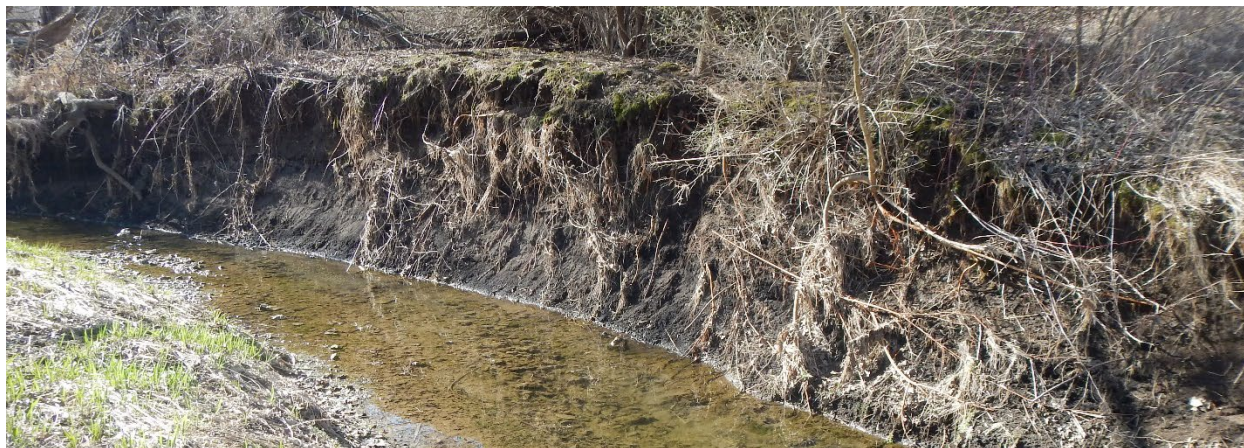
*-Severely eroded streambank, photo by Rebecca Olson*

The amount of severely eroding streambanks within the watershed was estimated as 51%, including 277,517 feet of streams that were not ravines. This high amount can be attributed to the steep topography of the watershed and intensive adjacent land uses combined with lack of vegetated filter strips and forest stewardship. Because of the high estimate, this plan focuses on stabilizing severely eroding banks only, not moderately eroding banks, in order to maximize the cost to benefit ratio of the efforts.

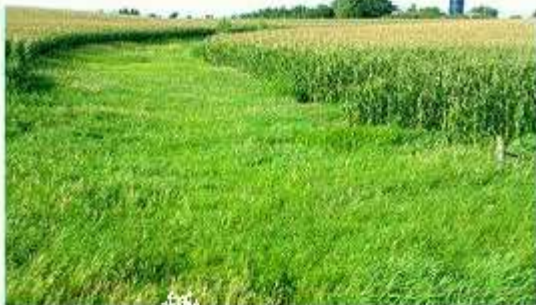
## Grassed Waterway with Vegetative Filter

A grassed conveyance can protect against erosion and helps to filter sediment and pollutants carried in runoff.

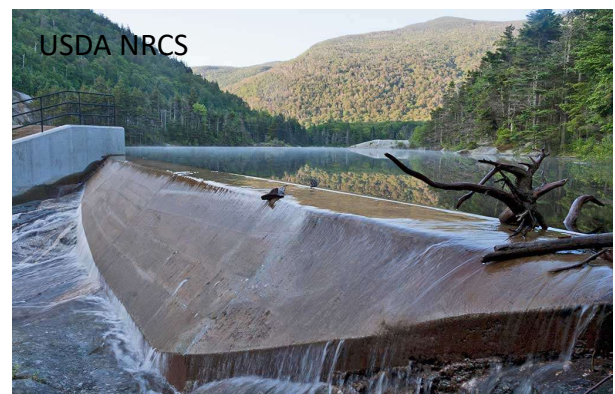
**Dry dams** are dam structures placed in areas that become inundated during rain events, particularly in ravine or other waterways that a steeply sloped. These dam structures go up and back down, thus allowing water to back up behind it. A culvert pipe should be installed to slowly let water pass through the dam. If the dam completely overflows then water will eventually flow over it. This structure is permanent, but only holds water when it rains. This structure can help to reduce water velocity and water force, thus decreasing erosion.

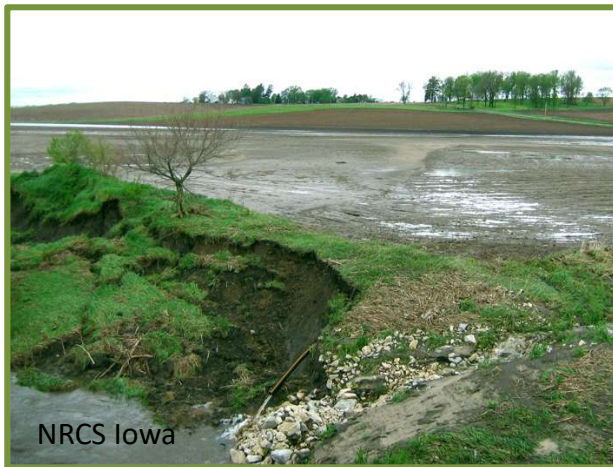
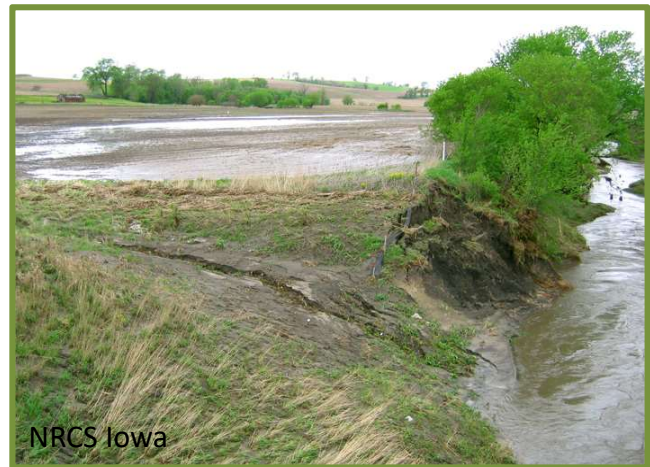
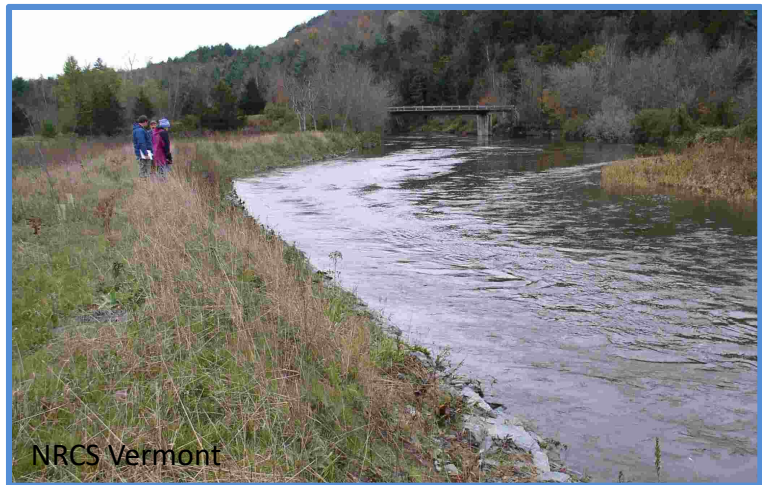
Streambank stabilization, or streambank and shoreline protection, is the process of employing methods that protect and stabilize banks of streams, shorelines of lakes, reservoirs, or estuaries, and constructed water channels. These methods are employed on banks that are particularly susceptible to erosion and siltation.

A channel is considered stable if the bottom of the channel remains at a relatively consistent elevation over long periods of time. Methods of protecting and stabilizing banks include altering channel capacity, installing riprap lining (use of stones and rocks to armour banks against water's force), vegetating the banks and channel, and creating channel crossing for livestock.

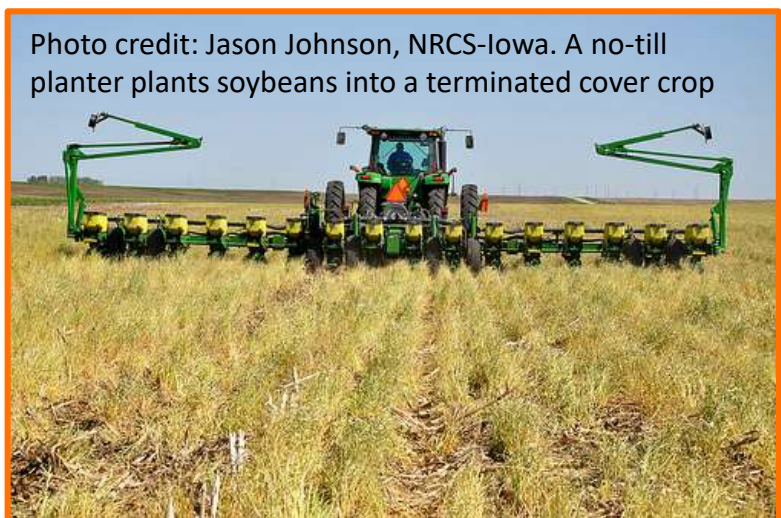
Tilling the soil with conventional plow-based systems leaves the soil vulnerable to erosion and intensifies agricultural runoff. Many farmers have been turning to more conservative tillage practices to reduce negative impacts. Reduced tillage as a BMP is the process of utilizing any tillage practices that are less intensive or aggressive than conventional tillage. For example, if a tillage process that requires less energy per unit area replaces a conventional tillage process, then the farmer has achieved reduced tillage. The term reduced tillage sometimes implies conservation tillage, but conservation tillage systems require farmers to cover 30 percent of the soil surface with residue after planting (EPA BMP Descriptions for STEPL and Region 5 Model 2018).

No till is already occurring throughout the entire East Fork Creek watershed on all farms when crops are rotated from beans to corn, corn to beans, or beans to beans. When rotating corn to corn, no till processes are difficult due to yield loss, rut formation, and periodic implementation of conventional tilling. It is recommended to perform continuous no till, since periodic tilling practices negates the benefits of no till.

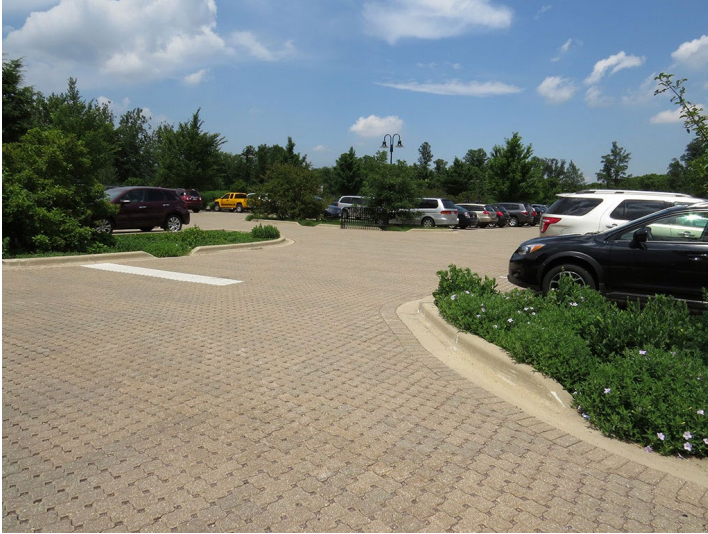
Morton Arboretum, Lisle. Permeable pavers

Permeable pavements infiltrate, filter, and/or store precipitation where it falls. These pavements are usually installed using permeable interlocking pavers. This best management practice could be cost effective where property values are high and flooding or icing is an issue (EPA, *What is Green Infrastructure?*).

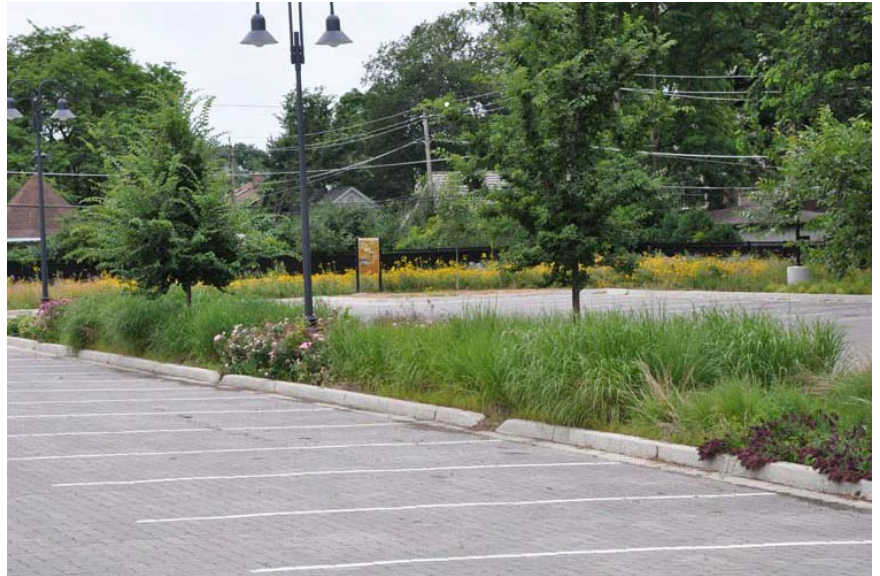
Permeable paving drains into a vegetated swale at Elmhurst College (Jaffe, M., et al 2010)

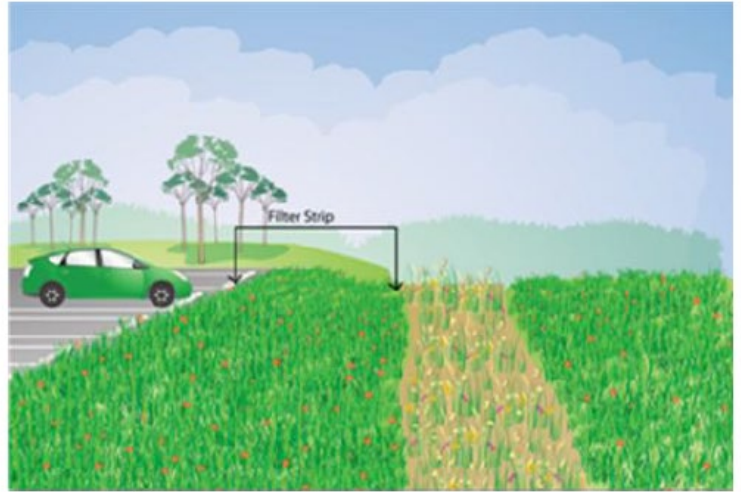
Figure 5.19. Illustration of a Filter Strip (MWRD, 2015)

Filter strips are vegetated sections of land located between impervious surfaces or agricultural fields and the waters to which they drain. When installed next to impervious surfaces, vegetated filter strips slow runoff, enable stormwater to pass through deep-rooted vegetation, and filter out pollutants before emptying into swales or other bodies of water. Filter strips may provide some reduction in stormwater runoff volume, but their primary function is to filter out contaminants in stormwater runoff.

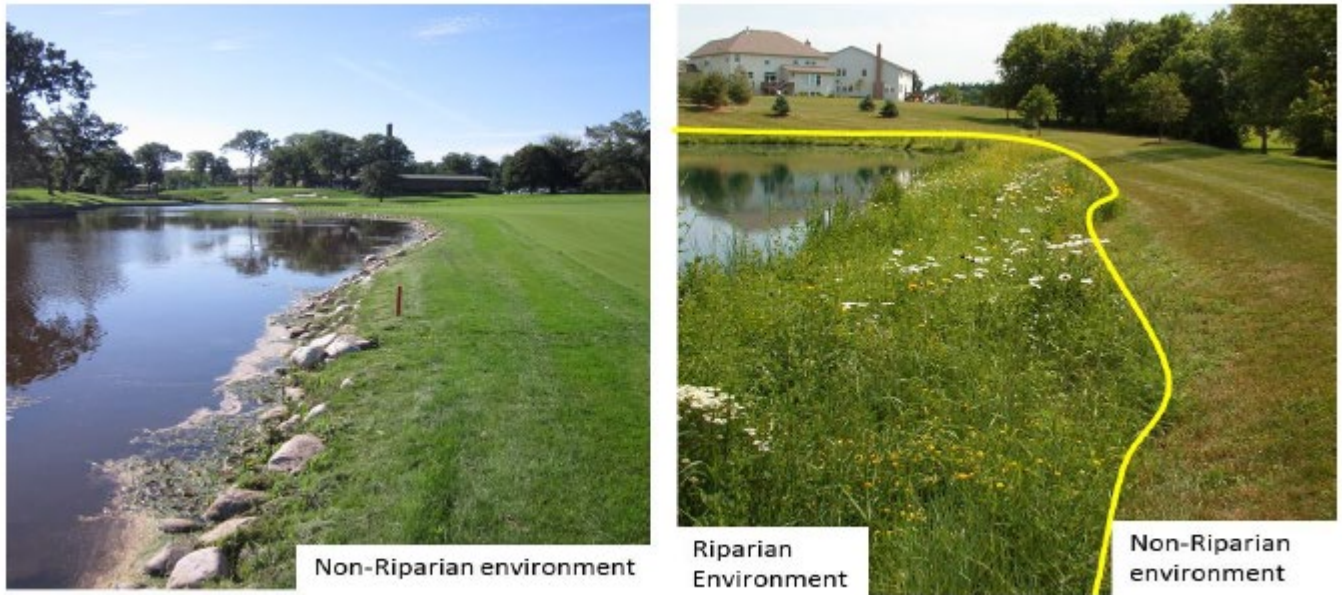
Figure 6.13. Examples of Riparian and Non-riparian Environments

Riparian Buffer Restoration is the process of creating a small plant habitat situated above the banks of lakes, streams, or ponds by installing hydrophilic plants, which grow in or near water and can tolerate various levels of saturation.

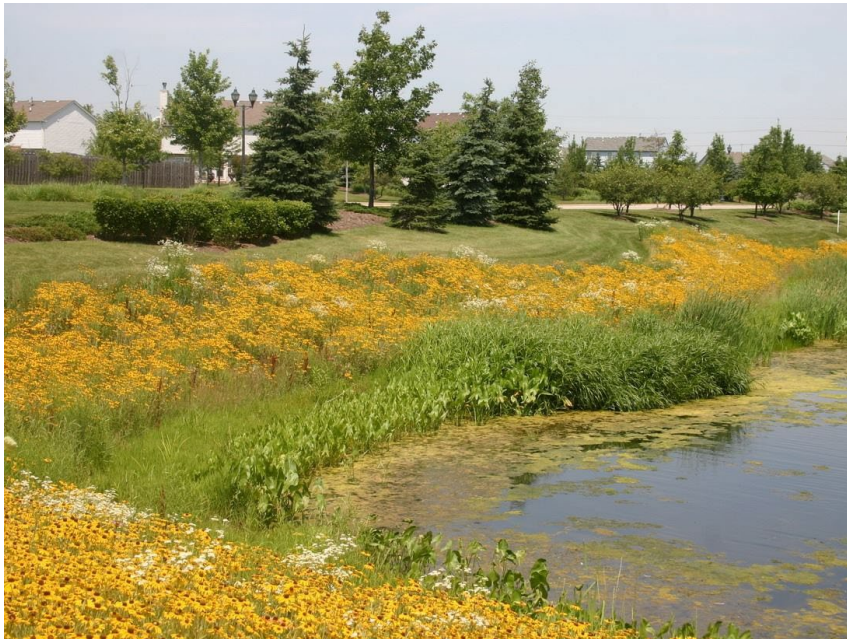
Native plant buffers (riparian buffers) should be at least 10 feet of dense native plants grown along the water's edge to allow pollutants to filter out and the banks to stabilize (Lake County Stormwater Management Commission, 2018).

Riparian buffer restoration above rip rap shoreline protection would detract geese and filter pollutants from stormwater running from lawns, parking lots, and other land uses next to the shoreline. Steep terrain leading to the lake heightens the need for riparian buffers because these buffers help to stabilize the land just next to the lake and provide erosion control.

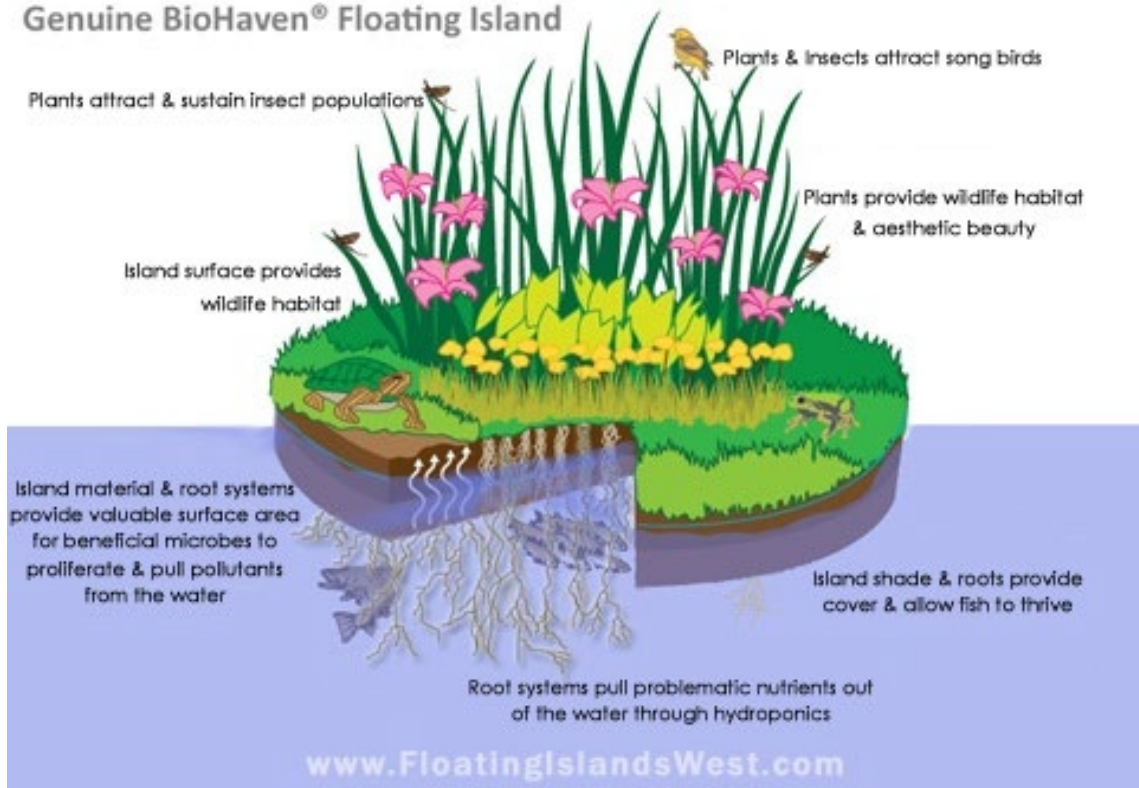
## Genuine BioHaven® Floating Island

Floating Treatment wetlands are manmade floating wetlands that when installed mimic naturally occurring wetlands in a concentrated capacity. 250 square feet of island translates to the equivalent filtering capacity of 1 acre of wetland. Natural wetlands are nature's water filters. Wetlands remove nitrates, filter excessive nutrients and sediment, recharge groundwater, and aid in erosion and flood control (Floating Islands West).

Floating islands allow filtering plants and good bacteria to float on the water in a constructed island, introducing a filtration capability where there wasn't an opportunity before. Floating islands are recommended in addition to preventative measures in areas where pollutant reduction goals cannot be met using preventative measures alone, or where other benefits such as fish habitat are desired.

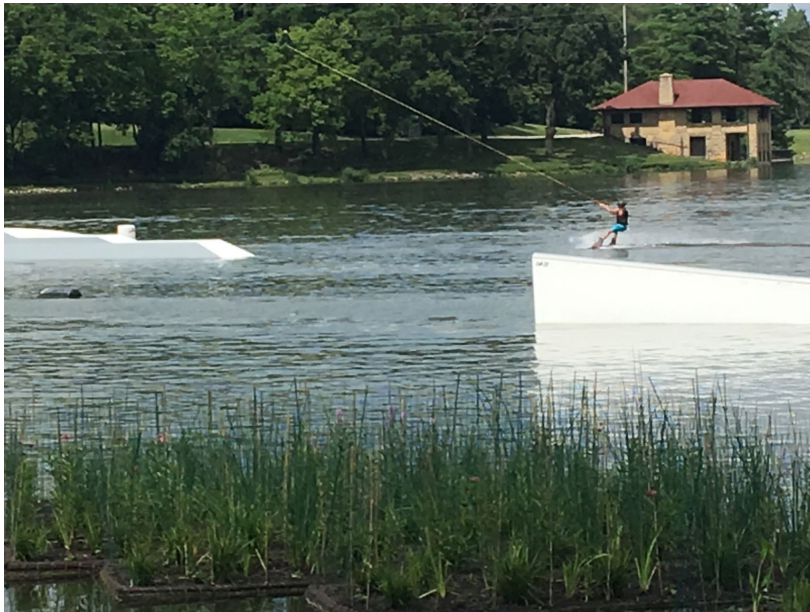
Floating islands  
in Levings Lake,  
Rockford, IL

Floating islands have seen successful implementation in various waterways with a diverse wealth of benefits: habitat enhancement, wetland and lake restoration, water quality improvement, stormwater treatment, and recreational use. BioHaven floating islands use marine-grade, non-toxic materials. These islands have also been shown to remove heavy metals, nutrients and other pollutants at removal rates of 63%-98%.
